APPENDIX D: Environmental

LAKE WORTH INLET
Palm Beach Harbor

Appendix D: Environmental
Attachment 1: 404 (b) Evaluation

SECTION 404(b) EVALUATION

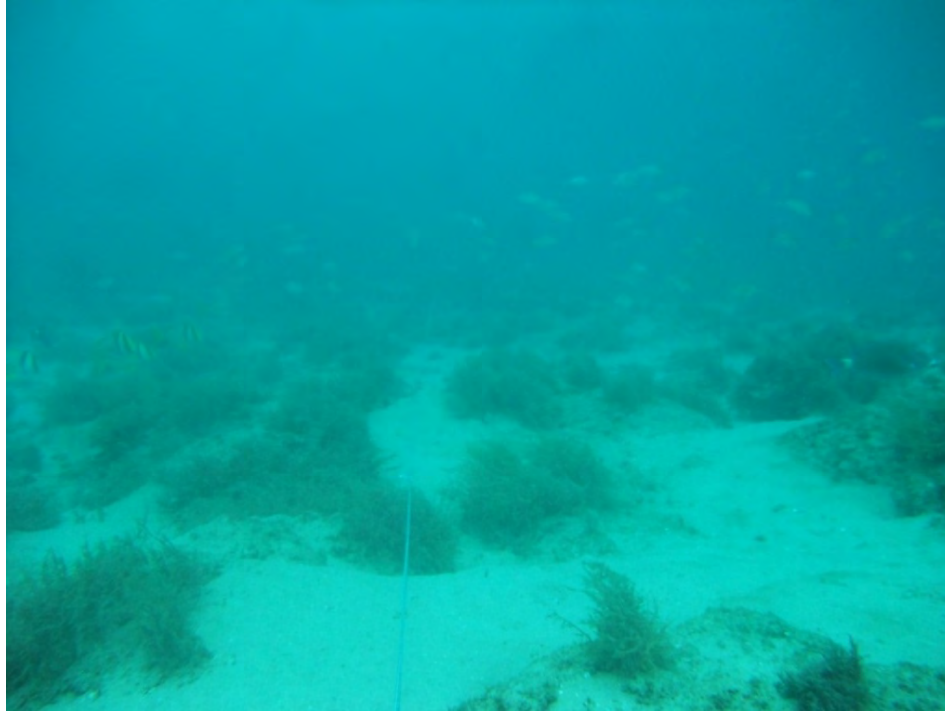
Figure 6 Sand with scattered hardbottom habitat with reef fish.

Continuous hardbottom, sand with scattered hardbottom and hardbottom ledge habitat included a number of benthic organisms unique to hardbottom habitat which were not found in seagrass habitats. Hardbottom benthic organisms were documented to the lowest taxonomic level and are listed in Table 5. Fish populations associated with hardbottom habitat were also documented (Table 6).

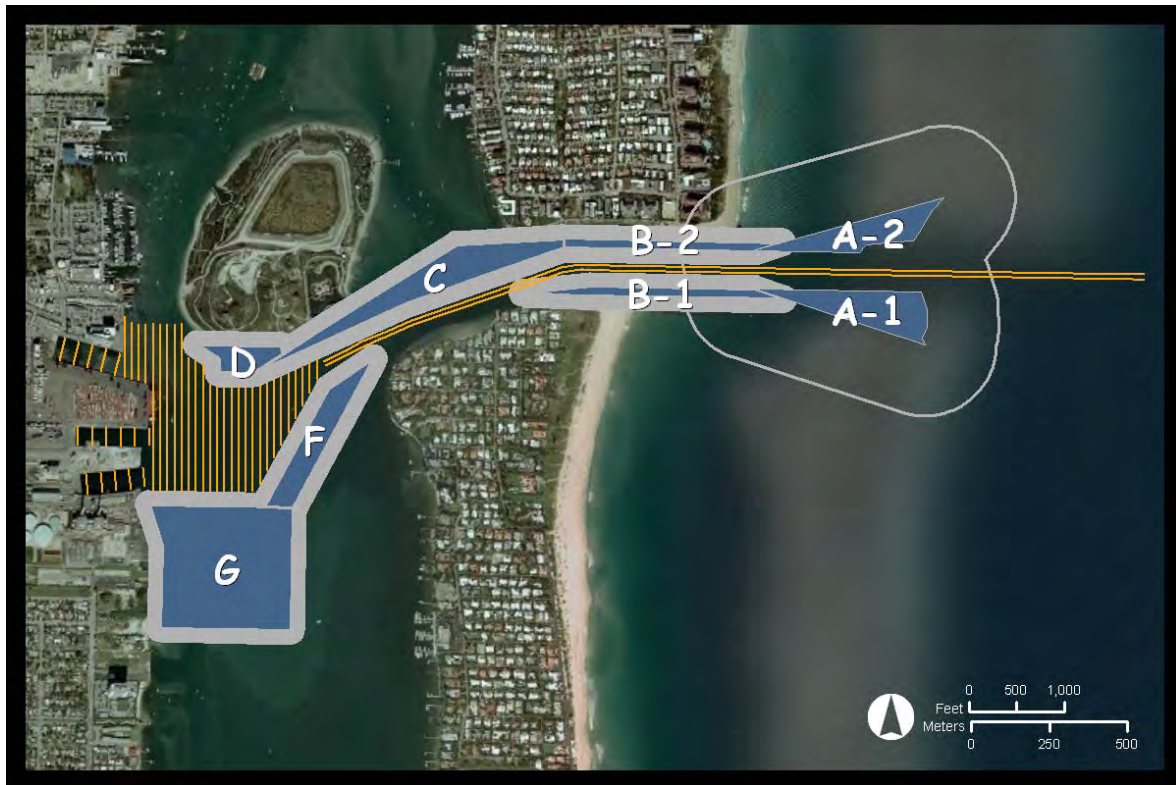
Figure 1. General location map for the Environmental Resources Report study area. Diver-investigated zones A-1 thru G (blue) with a 150-ft buffer (gray). Note the offshore 750-ft buffer (A-1 and A-2). Towed-video transects through the federal channel, turning basin, and existing berths are depicted in gold.

To encompass the proposed alternative footprints, the environmental resources survey of 2008 included an extensive diver survey of eight proposed expansion zones and towed video documentation of the existing federal channel, turning basin, and berths (**Figure 1**).

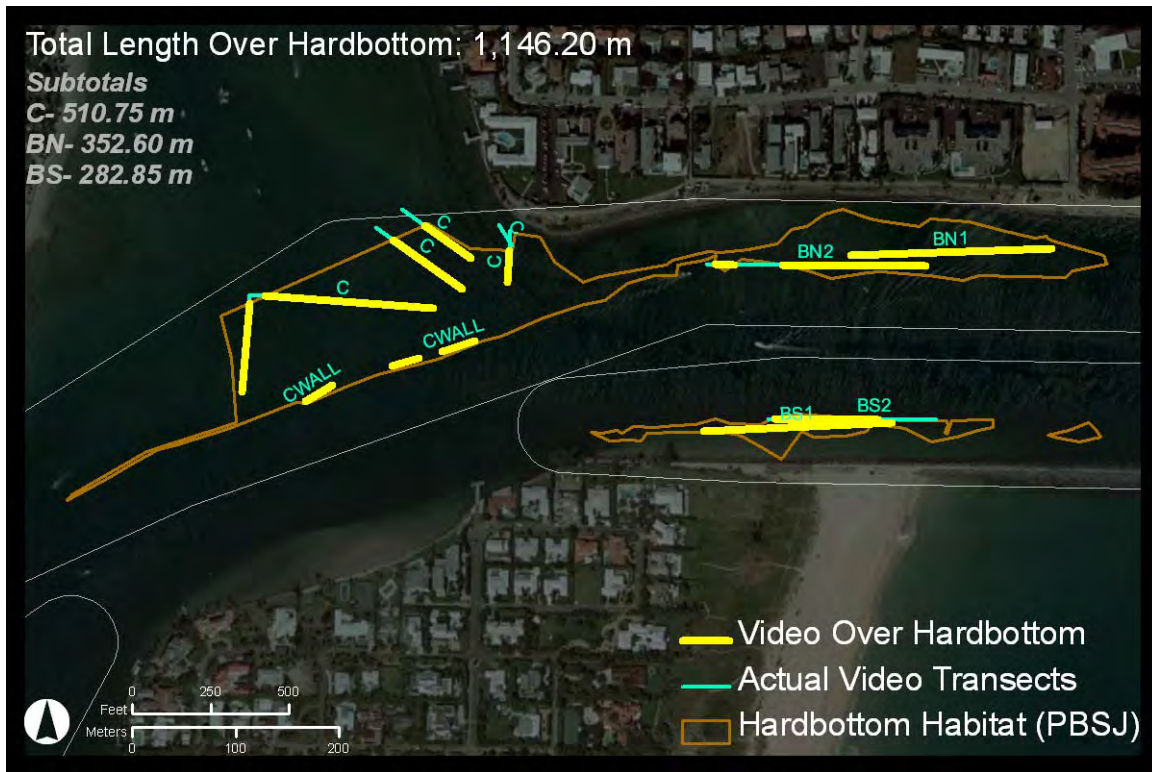
Figure 2. Dive location and interpolated distance (i.e., the straight-line distance from diver entry and exit points) for all handheld video shot within previously delineated hardbottom habitat.

(horizontal) and CWALL (vertical); B-1: BS1 (horizontal), BS2 (vertical); and B-2: BN1 (horizontal) and BN2 (vertical). These distinctions, along with the interpolated dive coverage (i.e., the straight-line distance from entry and exit points) for all handheld video dives can be seen in **Figure 2**.

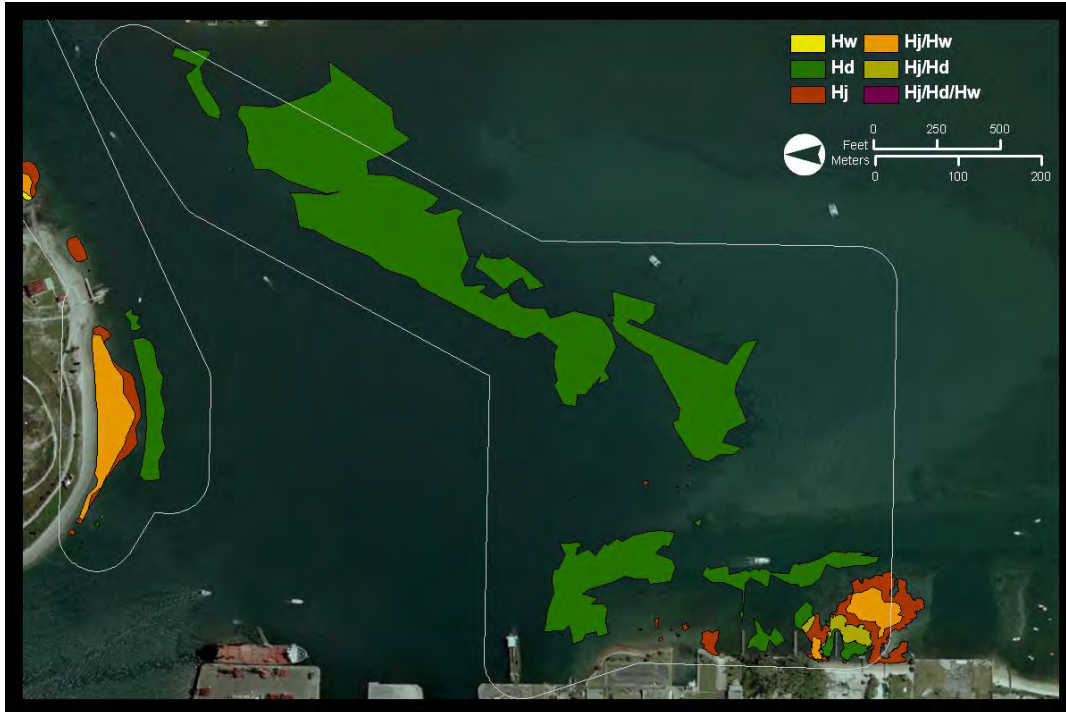
Figure 7. Location of seagrass habitat within Zones F&G. Polygonal features were located and mapped by biologists during the diver survey.

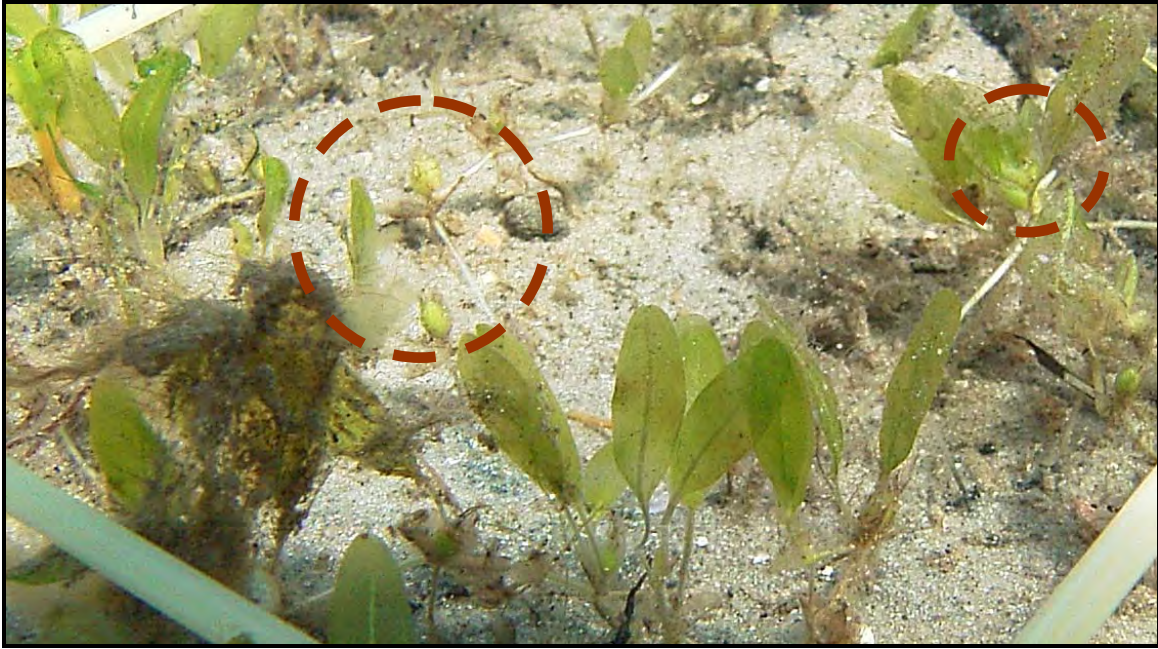
Figure 8. Photo documentation of the *H. decipiens* fruiting event observed on August 7, 2008. Image taken from quadrat #378 in Zone G. Red, dashed circles highlight visible fruits.

Intra-zonal trends in the distribution of species and patch-types appeared to be driven largely by depth and current flow. Shallower portions of zones (i.e., less than 3-m) were dominated by *H. johnsonii* interspersed with patches of *H. wrightii*, often at low density (see below). This was particularly evident in C&D (**Figure 6**) but was also seen in the southwestern portion of F&G (**Figure 7**). Deeper sections (>3-m) tended to support large expanses of *Halophila decipiens*, as dictated by substrate conditions; e.g., sufficient grain size and distance from migrating sand ripples. *H. decipiens*, particularly on the north-facing slope of F&G, was frequently found at depths exceeding 10-m. A fruiting event was recorded for *H. decipiens* in the shallower beds of the southwest portion of F&G on August 7, 2008 (Percent Cover Quadrat #378, **Figure 8**), indicating the reproductive health and productivity of the area for this species.

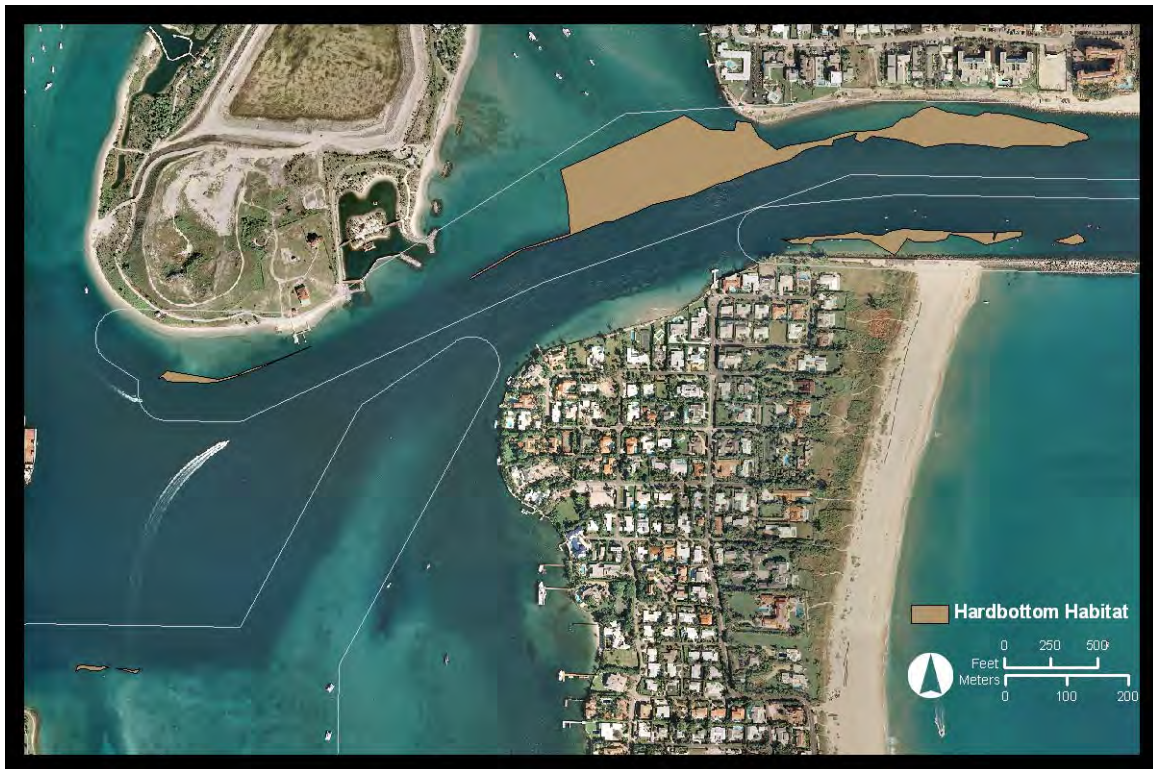
Figure 13. Location of hardbottom habitat identified during 2008 by biologists and mapped using DGPS.

Hardbottom habitat was located and mapped within 5 zones: B-1, B-2, C, D, and G (**Figure 13**). Total hardbottom areal coverage, excluding vertical surfaces, was estimated to be 14.98 acres (60,631.4-m²). Sum total coverage by zone (number of patches in parentheses) was B-1: 1.43 acres (2); B-2: 3.73 acres (1); C: 9.36 acres (1); D: 0.36 acre (1); and G: 0.10 acre (2). Individual patch sizes ranged from 0.03 to 13.09 acres, where the latter was split across Zones C and B-2 (9.36 and 3.73 acres, respectively). Zones B-1, B-2, and C were selected for further analysis (see below); however, archival video was shot for all identified areas of hardbottom.

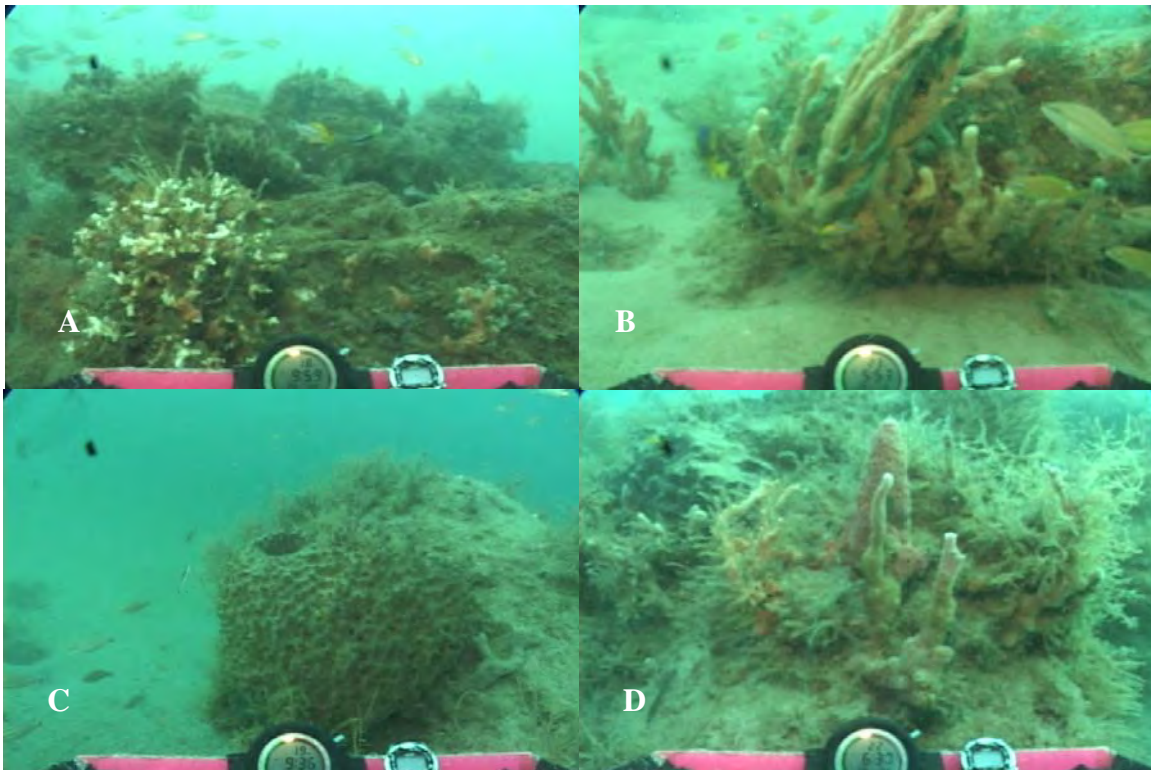
Figure 16. Hardbottom photographs captured from handheld video in zones D (A-B) and G (C-D).

Hardbottom in expansion zone D consisted of intermittent rock outcroppings along the ~20-ft. contour of the channel slope. A variety of hydroids, sponges (*Amphimedon* sp., *Niphates* sp., *Ircinia* sp., boring, etc.), and fish (including bandtail pufferfish, sergeant major, juvenile porkfish, and juvenile cocoa damselfish) were observed. *Oculina diffusa* and *Siderastrea* spp. were the only coral taxa found. Hardbottom in expansion zone G consisted of large rock boulders and rock outcroppings. Similar hydroid and sponge taxa observed in expansion zone D were observed in zone G. Observed fish included gray angelfish, juvenile and adult porkfish, grunts, and bandtail pufferfish. Hardbottom photographs captured from handheld video in zones D and G are depicted in **Figure 16**.

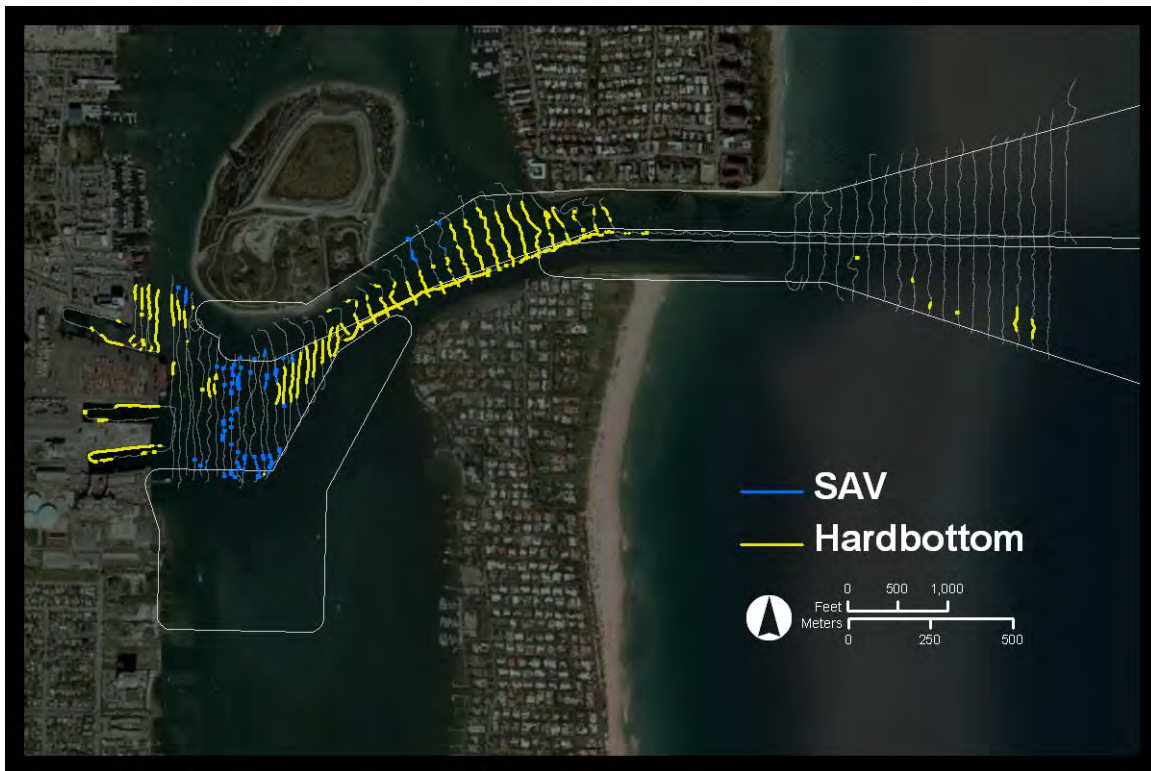
Figure 20. Location of hardbottom habitat and SAV identified from towed video in A-1, A-2, C, the turning basin, the commercial ship channel, and the berths. The yellow points/lines represent hardbottom and the blue points/lines represent SAV. Points indicate single instances of hardbottom/SAV whereas lines represent continuous hardbottom features or SAV.

Hardbottom habitat and SAV were located and mapped within A-1, A-2, C, the turning basin, the commercial ship channel, and the berths (**Figure 20**). Total hardbottom and SAV coverage (linear meters) were estimated to be 5,441.56-m and 210.93-m, respectively. **Table 4** presents the total coverage of hardbottom and SAV by survey area. Individual hardbottom areas ranged from 0.04- to 498.26-m (both in channel) while individual SAV patches ranged from 0.00- to 40.6-m (channel and C, respectively). It is important to note that the westernmost C-transects, collected in Area D, were not qualitatively analyzed as these areas were previously and thoroughly mapped via SCUBA or snorkel. Also, not all towed video was useable for qualitative analysis. In some instances, increased speed, poor visibility, or increased height off bottom made identification of benthic components difficult.

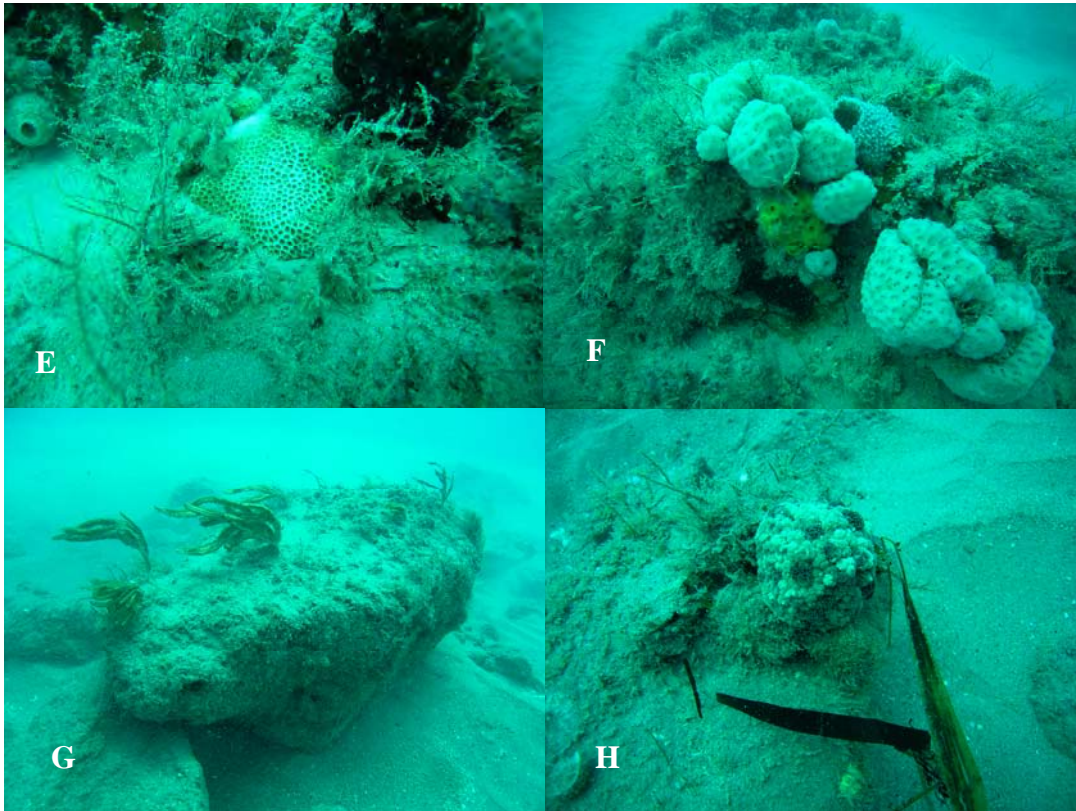
Figure 21. Subset of photographs collected in expansion zone A-1. A) Photograph of *Cliona delitrix* at site V2. B) Hardbottom community photographed at site 7. Stinging hydroids (*Macrorhynchia* spp.) located in forefront of photograph. C) Unidentifiable hydroids and lumpy sponge, *Monanchora* sp., observed at site V4. D) Colony of *Siderastrea* sp. observed at site V4. E) Variety of hydroid species, a colony of *Siderastrea* sp., and the white condominium tunicate, *Eudistoma* sp., at site V4. F) Hardbottom community photographed at site V4. Organisms photographed include the white condominium tunicate (*Eudistoma* sp.), vase sponge (possibly *Niphates* sp.), yellow, massive sponge (possibly *Aiolochoira* sp.), and a variety of hydroids, including the algae hydroid (*Thyroscyphus ramosus*). G) Large rock boulder with several gorgonians of the Genus *Pseudopterogorgia* at site V6. H) Rare in Florida, a berried anemone (*Alicia mirabilis*) photographed at site 7.

The benthic composition of expansion zones A-1 (south) and A-2 (north) consisted mostly of sediment and shell hash. Six hardbottom areas were identified from the towed video collected in expansion zone A-1. Hardbottom was not observed in A-2. A subset of hardbottom photographs collected in A-1 are presented in **Figure 21**.

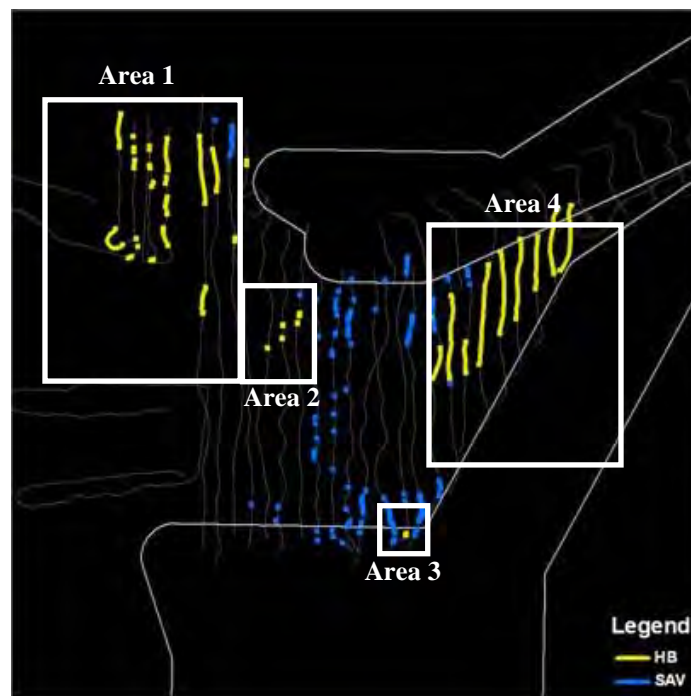
Figure 22. Four areas of hardbottom located in the turning basin.

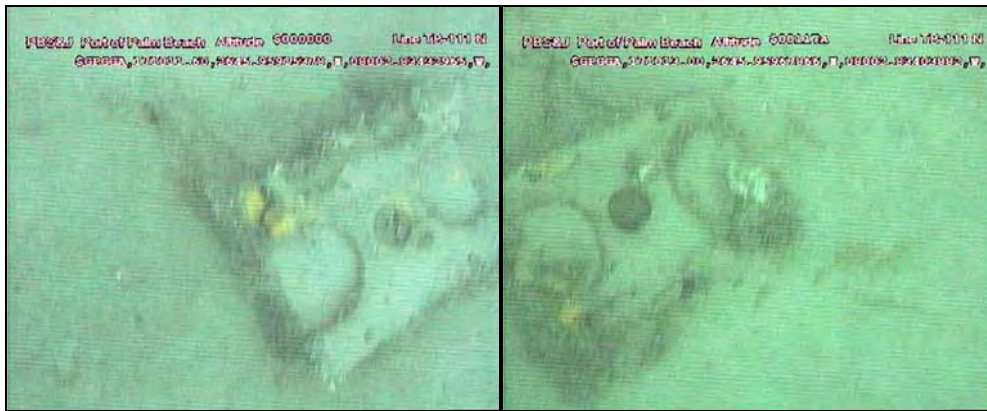
Figure 25. Hardbottom images captured from towed video within Area 3. Transect 111: two concrete blocks colonized by sponges, hydroids, and turf algae.

Area 3: A single hardbottom point located on the southern boundary of the turning basin. Hardbottom consisted of two concrete blocks (debris) colonized by sponges, hydroids, and turf algae (**Figure 25**).

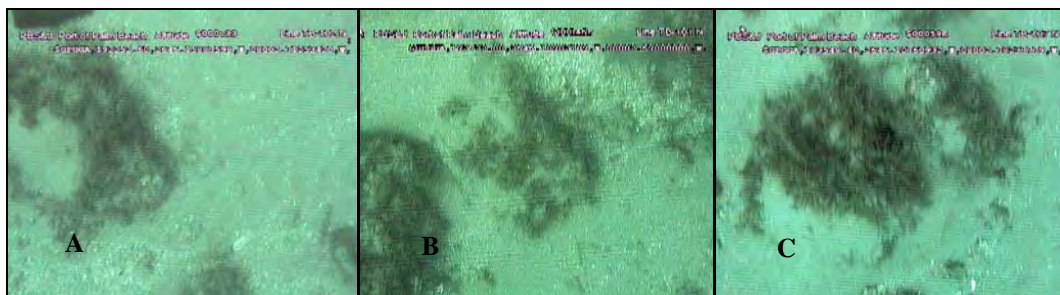
Figure 26. Hardbottom images captured from towed video in Area 4. Small to large rocks colonized by turf algae and hydroids. Photographs captured from transects 102 (A), 101 (B), and 107 (C).

Area 4: Large hardbottom area located on the northeastern side of the turning basin. Hardbottom characterized by scattered, small to large rocks with attached turf algae, hydroids, and sponges (Figure 26).
